# RESEARCH BRIEF

2001/001

## Developing A Durable Polyurethane Sealant That Can Withstand Tropical Conditions

This research is targeted at developing a polyurethane construction sealant that can withstand the harsh conditions of the tropical climate.

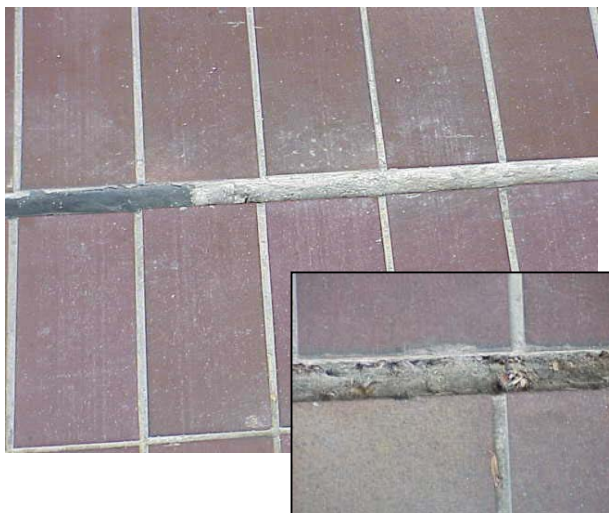
Figure 1. A two-metre long commercial sealant peeled off the substrate due to adhesive failure on the external expansion joint of a building.

Serious sealant failures have been observed on external joints in buildings and structures in tropical countries like Singapore (Figures 1 & 2).

The underlying cause is that the currently used commercial sealants are formulated for non-tropical countries and considerations of the impact of the tropical climate were not made during their formulation. As a result, there is a need for a construction sealant that is specially developed for the tropics.

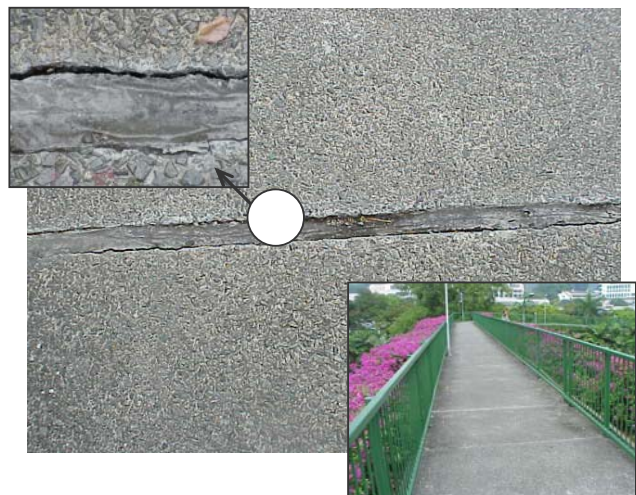
Figure 2. A length of failed commercial sealant on an overhead bridge.

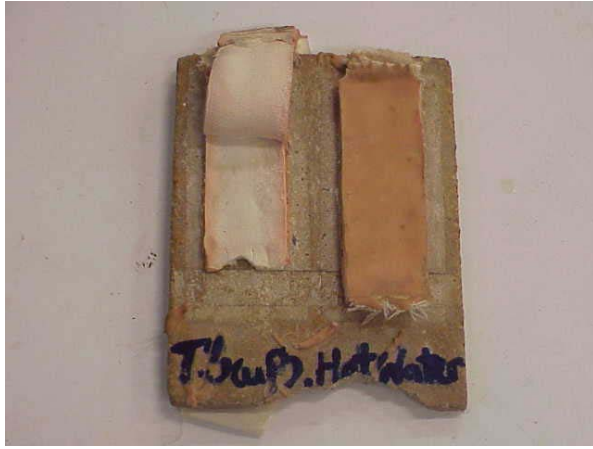
Figure 3. 100% cohesive failure was shown in the peel-adhesion test (ASTM C794) of this sealant to concrete without primer after a 28-day immersion in 70°C water. (The larger the percentage of cohesive failure given by ASTM C794, the stronger the peel adhesion.)

- 1) It retained more than 90% of its tensile strength after a 28-day immersion in 70°C water and 500-hour QUV weathering (ultraviolet at 70°C and condensation at 50°C).
- 2) Good peel adhesion to concrete without the need of a primer (ASTM C794) (Figure 3).
- 3) Good resistance to movement capability (repeated ASTM C719) (Figure 4).

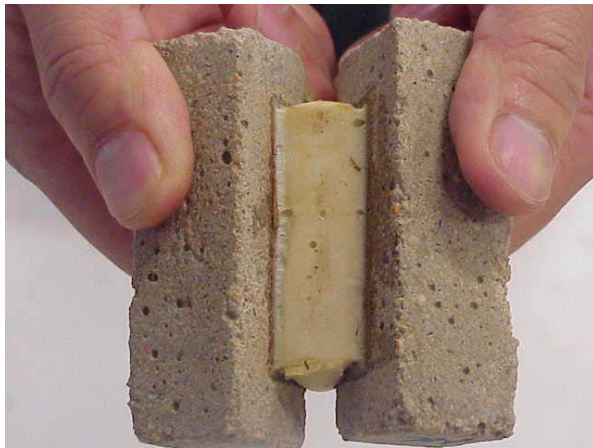
Figure 4. Perfect adhesion and cohesion were shown above after the fifth cycle of repeated ASTM C719 on this sealant.

There was less than 5% total adhesive and cohesive failure loss after the fifth cycle. (Each cycle comprised a 7-day immersion in ambient water, 7-day exposure to 70°C air and 10 cycles of 25% alternating extension and contraction.)

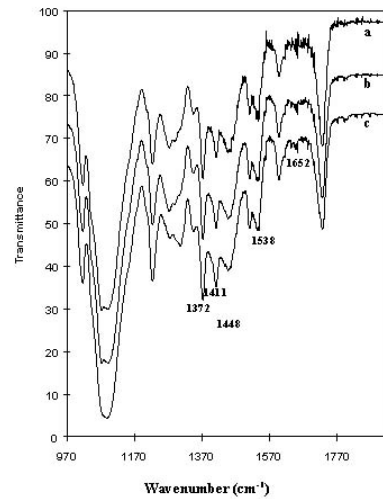
Figure 5. ATR spectra of the surfaces of sealant B: (a) control specimen; (b) specimen immersed in 70°C water for one week; (c) specimen immersed in 70°C water for four weeks. (Based on ATR results, no obvious degradation occurred due to hot water immersion.)

Advanced instruments like Attenuated Total Reflection (ATR), Differential Scanning Calorimetry (DSC) and Thermal Gravity Analysis (TGA) were also employed to characterise this product (Figures 5 to 7).

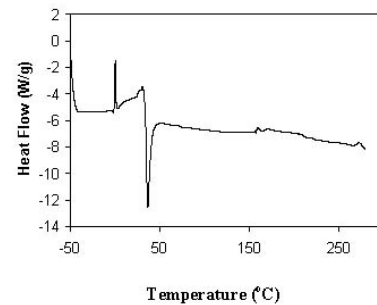
Figure 6. DSC result of this self-developed sealant.

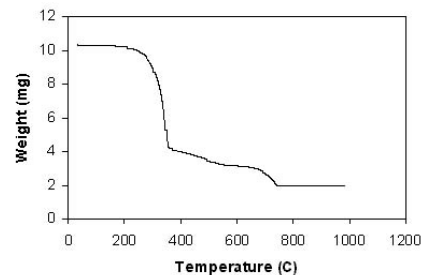
Figure 7. TGA graph of this self-developed sealant.
