Evaluating the Performance of a New Polyurethane Sealant for External Joints under Tropical Conditions

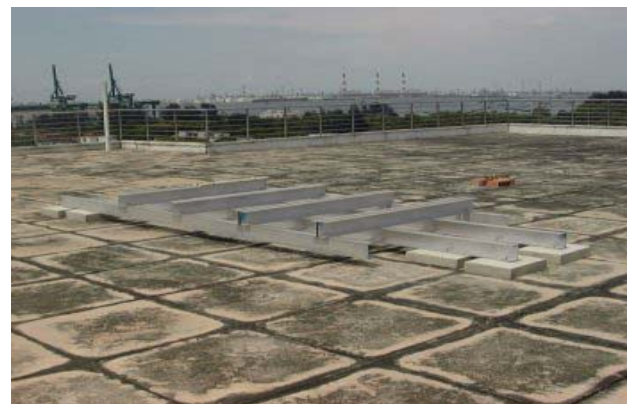
Figure 1. Set-up of the Horizontal Weathering Rack (HWR)

An on-site horizontal weathering rack (HWR) was developed to simulate the tropical conditions, combining the simultaneous effects of joint movement, temperature, humidity, rainfall, water retention and sunlight (Fig. 1). The simulated movement of joints was achieved by using the high level of extension and contraction of aluminium under temperature change. The 10m long aluminium rack with concrete slabs bolted on it allows sealants to be tested on concrete surfaces. Test results have shown that the rack is efficient in subjecting test specimens to real level construction joint movements exposed to the tropical environment.

The simulation of the tropical conditions combines the effect of joint movements and weathering conditions like temperature, rainfall, water retention and sunshine. The simulated movement of joints was achieved by using the high level of extension and contraction of aluminium under temperature change. The conception created a self-designed ten-metre-long aluminium rack which can simulate the level of joint movement brought about by much longer concrete slabs so that a real level of construction joint movement was obtained for the performance evaluation.
